Technical Note N-855

MAINTENANCE PAINTING OF BUILDINGS--FIRST PROGRESS REPORT

8 November 1966

U. S. NAVAL CIVIL ENGINEERING LABORATORY
Port Hueneme, California 93041

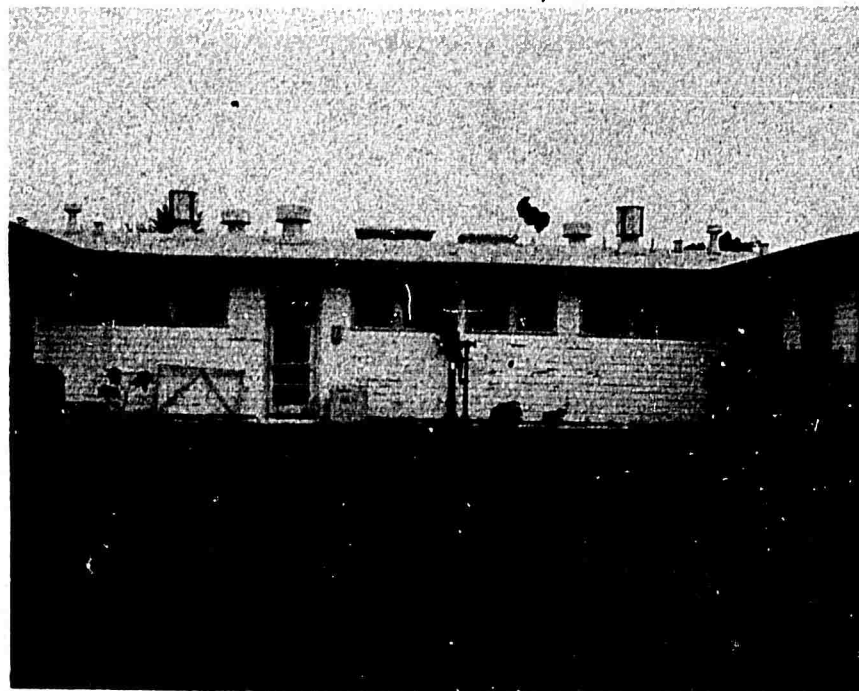
A high degree of surface preparation was prescribed for the hospital to obtain a better than normal paint job. The condition of the old paint was bad (i.e., cracks and flakes) on the southern wings and in the patio, see Figure 2, but the northern wings of the building were generally in good condition. All loose paint was removed with a putty knife or a disk or vibrator sander and the rough edges were feathered to prevent lifting or curling of the base paint. Chalk and dirt were removed with steel wool, or, if the old paint had no cracks and flakes, by water and a stiff brush. The bare wood was primed with TT-P-25a the same day it was sanded to prevent absorption of moisture overnight.

Figure 2. Condition of the old paint on a southern exposure of the Construction Battalion Center Base Hospital.

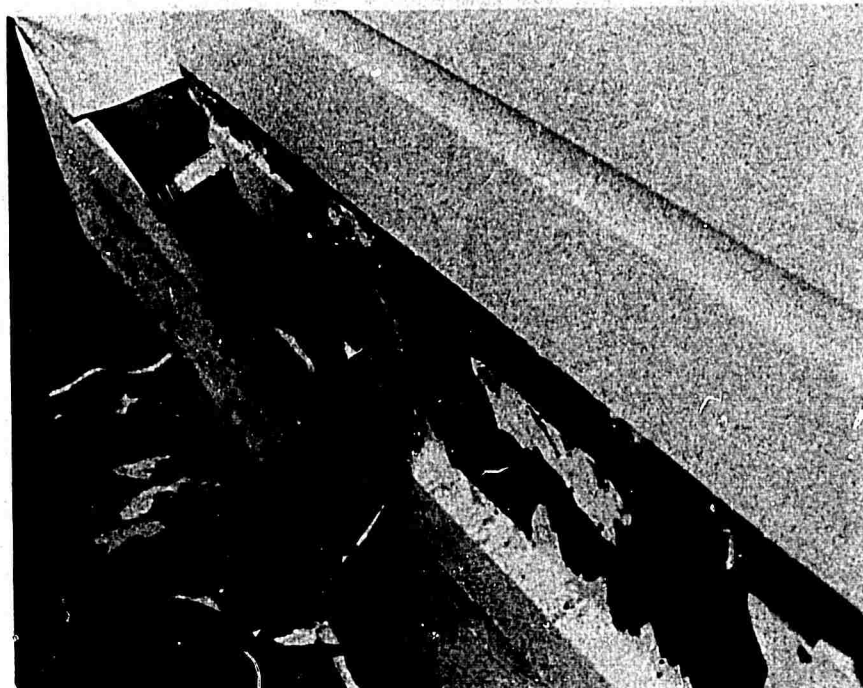
The old paint on the north side of the hospital seemed to be in good condition (no cracks and flakes) and some areas were washed with water to remove the chalk and dirt. On two isolated areas, blisters were noticed after the wall had been washed with water, allowed to dry for a week and then coated with TT-P-102a, a slow drying linseed oil paint. The blisters may have existed before washing with water or before painting with TT-P-102a, but they were not noticed until 24 hours after the paint was applied. Figure 3 shows adhesion failures and the flexibility of the old paint after the wall had been washed, allowed to dry for a week, and coated with TT-P-102a. The inside wall directly behind the blisters was dry but the blisters were full of water when they were noticed. Laboratory tests showed that water as well as linseed oil paint can soften the old paint which is on the hospital.

Figure 3. Adhesion failures and softening of the old paint 24 hours after washing with water and applying TT-P-102a.

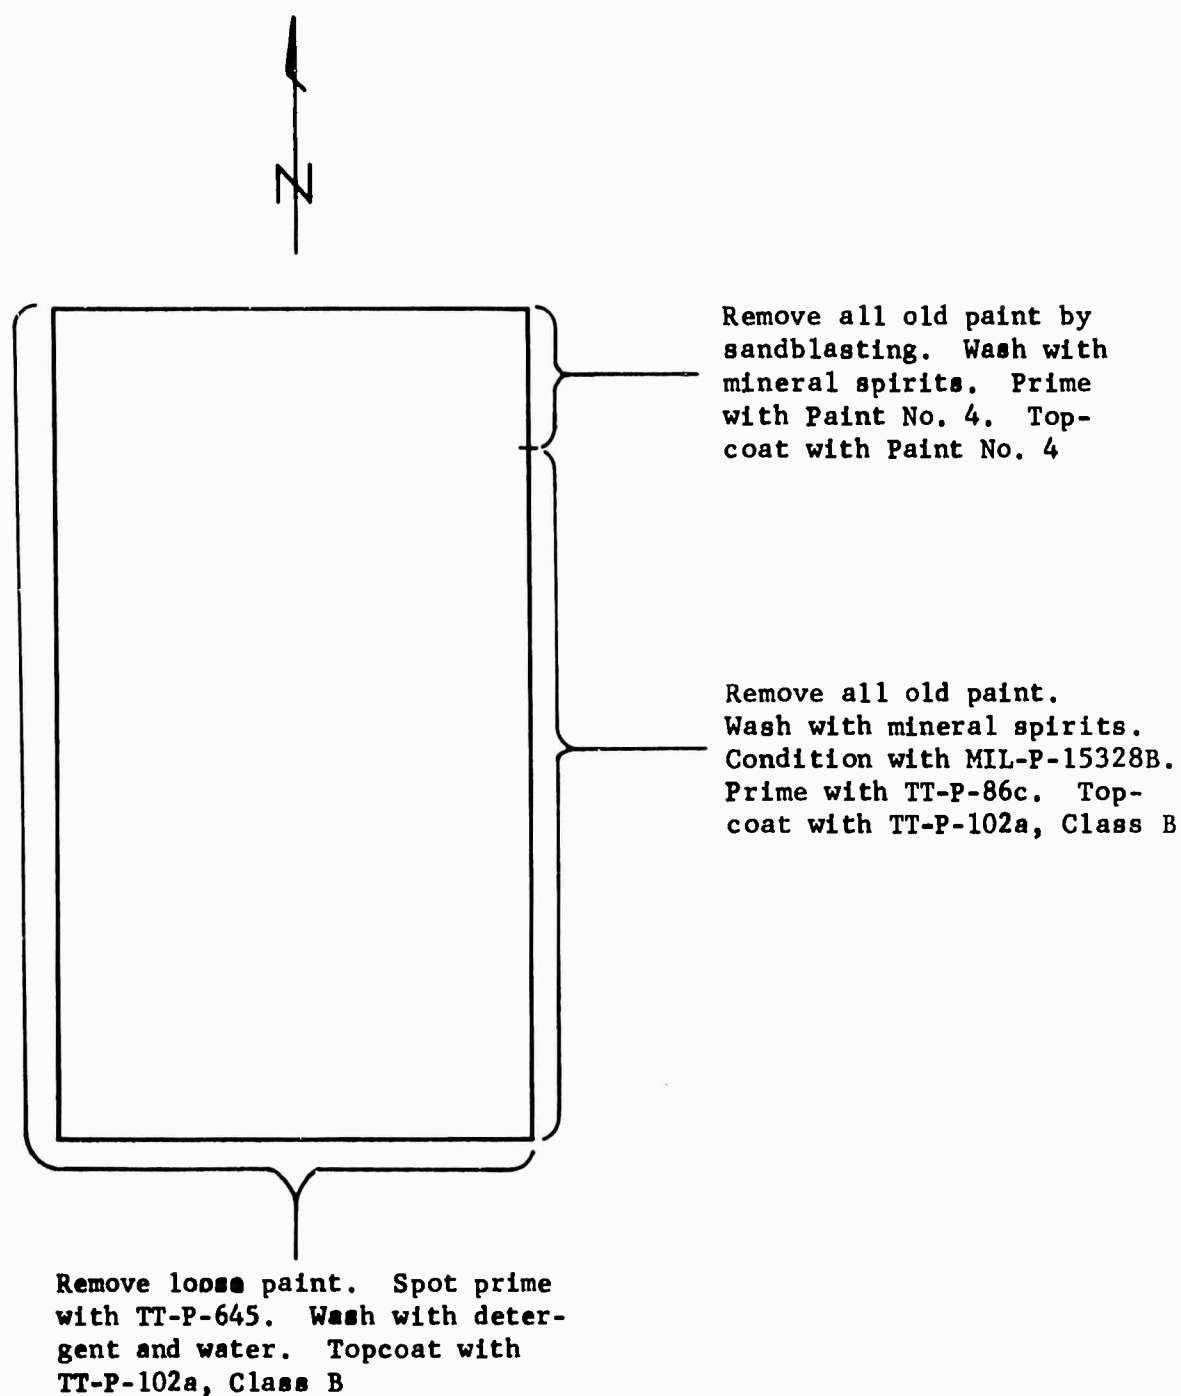
Figure 4. Repainting system for Building 563.

Loosely adherent paint on the east side of Building 563, the protective coatings laboratory, was scraped off and rusted areas were sand-blasted lightly and the metal was then washed with mineral spirits. The galvanized iron was then treated with a coat of wash primer, MIL-P-15328b, followed by a coat of red lead primer, TT-P-86C, except for a ten foot strip which was primed and top coated with Paint No. 4. Tightly adherent paint on the west side of Building 563 was cleaned by brushing the surface with a detergent solution after priming when necessary with TT-P-645. The topcoat on all of the building except the ten foot strip was spray painted with two coats of TT-P-102a, class B, color. The ten foot strip was topcoated with two coats of Paint No. 4. Figure 4 illustrates the treatments for Building 563.

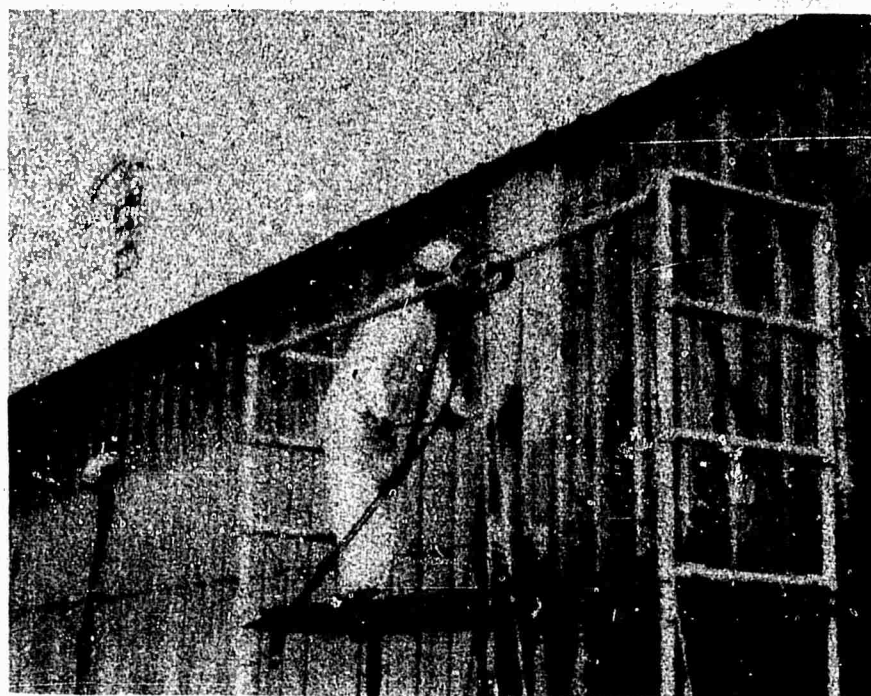
Figure 6. Brushing detergent solution on the surface.

The paint on Building 564 was tightly adherent and was washed with a detergent solution after wire brushing the rust spots and priming as necessary with TT-P-645, see Figures 5 and 6. The topcoat on all of this building except the north side was spray painted with two coats of Paint No. 4, an acrylic emulsion. Paint No. 4 has a formulation similar to TT-P-19b but contains barium metaborate, a moldicide developed by Buckman Laboratories, Inc.,¹ as one of the pigments.
